Manhole Inspection Summary

Manhole # S45EE_053MH

Insp Date: **12/20/07 12:24 PM**

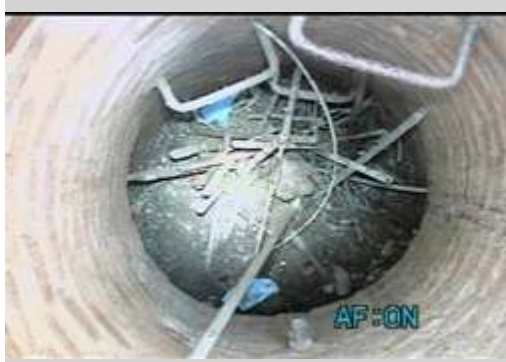
Defect 1

Condition: ☐ Sound ☐ Cracked ☐ Root Intrusion ☐ Deteriorated ☐ Leaks ☒ **Debris**

Steps Count: **4** Missing: **1** ☒ **Corroded**

bench and channel debris, missing step 1

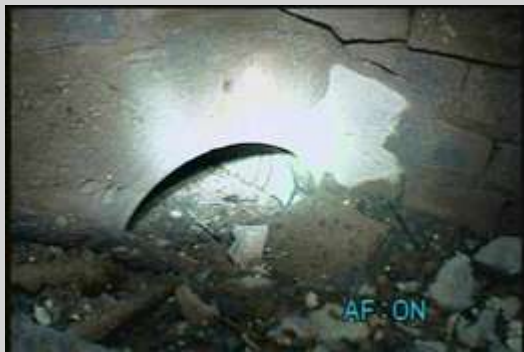
12 O'Clock Outflow

8 in. Circular Gravity Sewer
Pipe Out @ 12 O'Clock

Deposits: ☐ None ☐ Mud ☐ Sludge ☒ **Debris** ☐ Grease

Silt Depth: **4** (in.) Deposits Extent: **Heavy**
